White Paper

Short Circuit Installation Problem

White Paper: Short Circuit Installation Problem

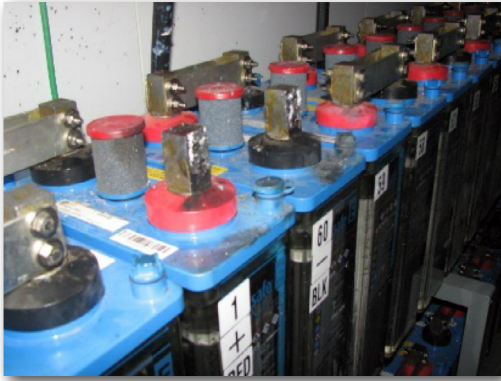
An electrical contractor created a short circuit during a battery installation.

In 2016, we received a call for assistance from one of our customers when their “embedded” electrical contractor installed two battery systems in a new unit at their refinery. During one of the installations, the electrical contractor inadvertently connected cell #1 to cell #60 in one of the 120-vdc battery strings.

Fortunately for the installer, there was a loose connection between cell # 39 and cell #40 further down the string. This loose connection acted as a fuse for the short. Unfortunately, this did result in the disintegration of the connector nut and bolt hardware, turning the parts into shrapnel.

No one was injured during the event but five of the cells were damaged requiring replacement to get the string in service.

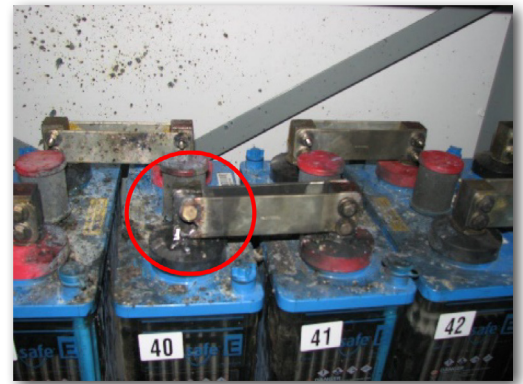
- The battery was positioned on the rack with cell #1 setting adjacent to cell #60. The first and last cell of a string are normally separated by the length of the rack or placed on different rows of the rack
- The installer either was not paying attention to what they were doing or had no training on how to build a battery system when they completed the loop by connecting cell #1 and cell #60

- Our technical service manager was on-site the day after we received the call to evaluate the damage and to develop a plan of action to get their system up and running as soon as possible
- Damaged cells were identified and removed from the damaged string
- Using identical cells from the second string on-site, we were able to build a fully functional 120-volt battery for the customer’s new unit allowing them to bring the new system on-line as scheduled
- A capacity test was performed on the battery to ensure that it would support the connected load
- Replacement cells were ordered
- When the cells were received, we returned to the site to reconfigure both battery strings
- A final acceptance test was performed on both
- Both battery strings passed and were placed in service
